INDOOR AIR QUALITY REASSESSMENT

**Squannacook Elementary School
North Middlesex Regional School District
66 Brookline Road
Townsend, Massachusetts**

Prepared by:
Massachusetts Department of Public Health
Bureau of Environmental Health Assessment
February, 2001

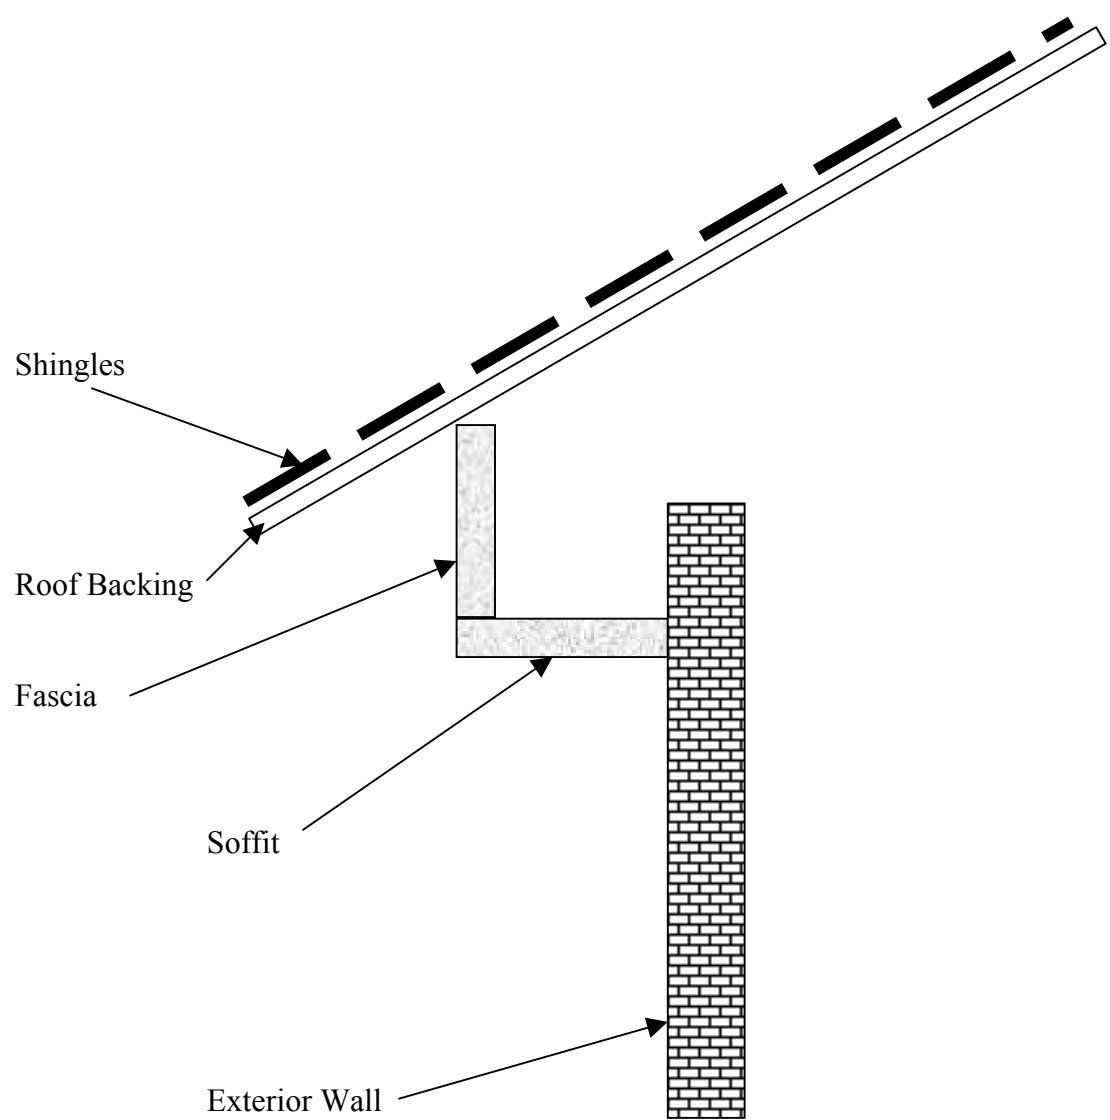
Figure 1

Lack of roof water drainage also results in excessive moisture exposure to the wood of the fascia (see Figure 1). Spaces in the fascia (see Picture 5) immediately underneath shingles at the edge of the roof appeared to be blackened in some areas, which could indicate both excess water exposure and mold growth.

Components of the Roof/Exterior Wall Structure

1. Consider installing a gutter/downspout system on the edge of the peaked roofs of the building to direct water away from the base of the building. The installation of a drainage system may also be necessary to direct water away from the foundation.
2. Replace water damaged fascia material. The edge of the roof shingles should be repaired in a manner to limit water contact with fascia materials (see Figure 1).

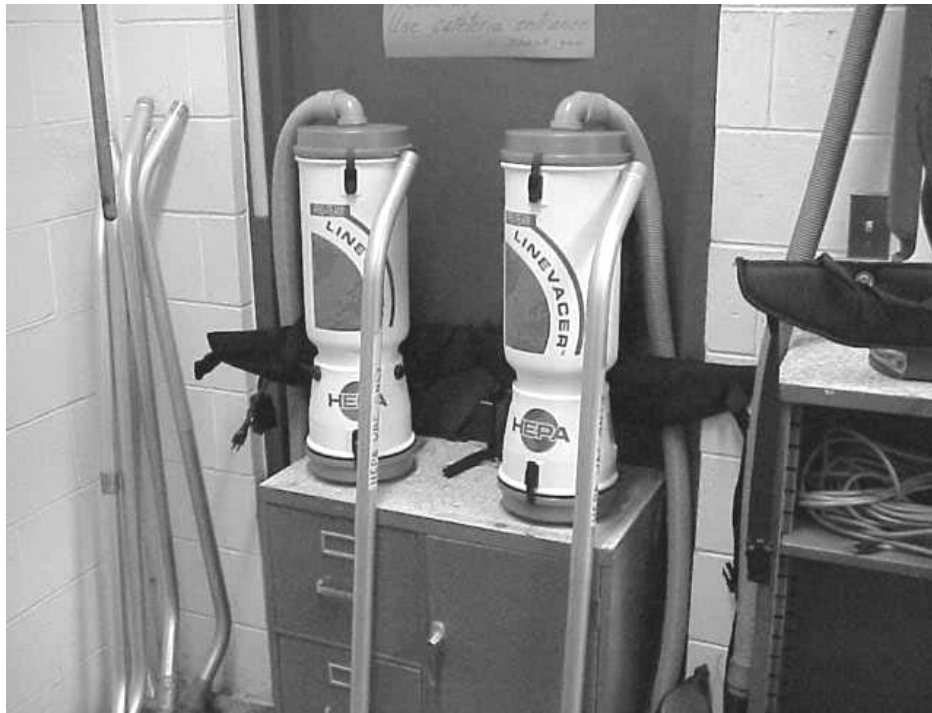
Picture 1

HEPA filter vacuum cleaners were acquired (see Picture 1).

HEPA Filter Vacuum Cleaners

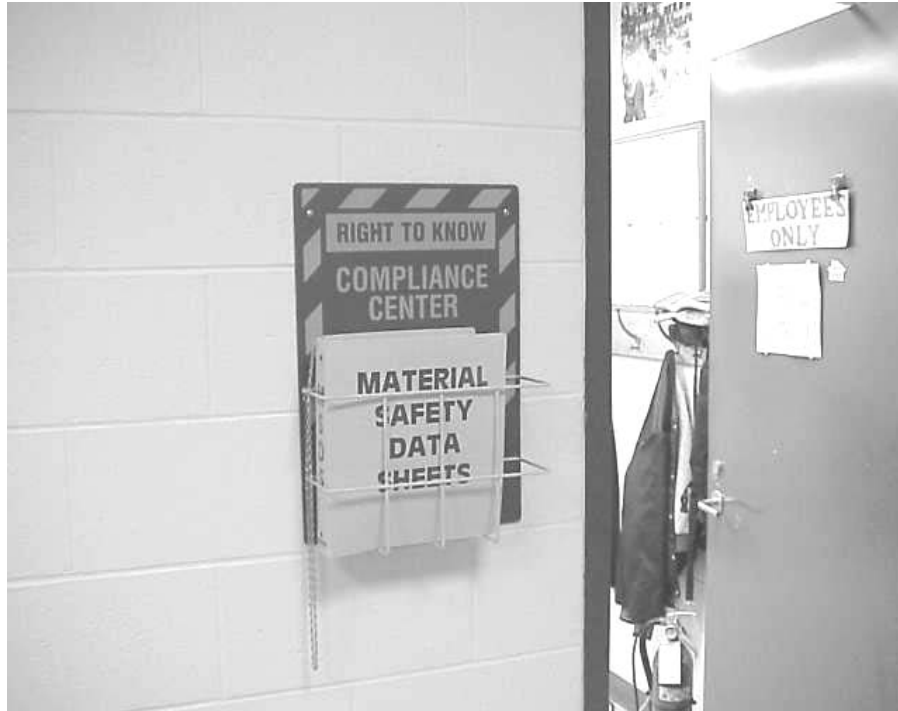
Picture 2

MSDS for maintenance materials used in the building are located in a three-ring notebook and placed in a special MSDS information station (see Picture 2).

MSDS Storage Rack and Binder

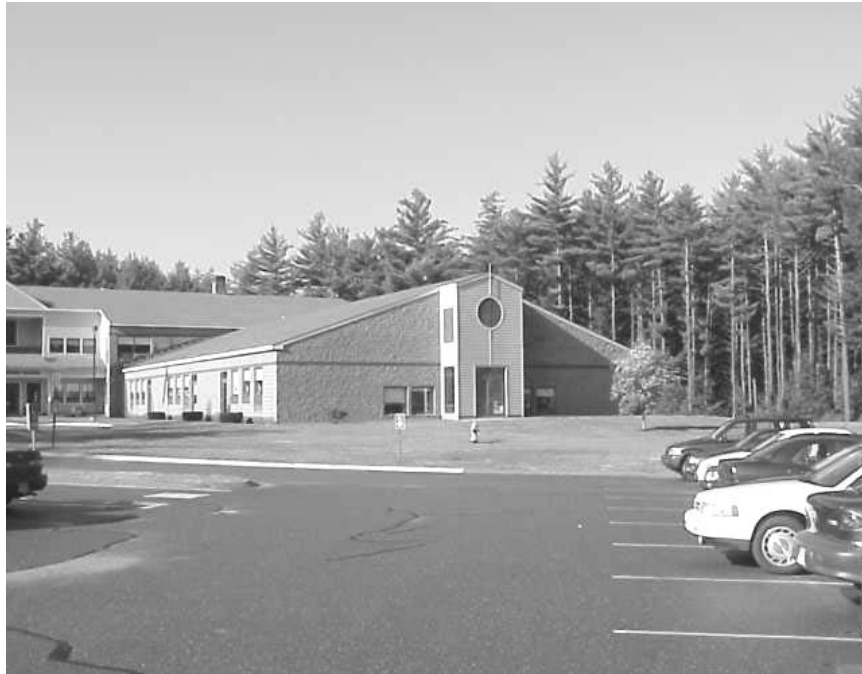
Picture 3

As noted in the previous report, contractors involved in the installation of the roof are in litigation with the North Middlesex School District. At issue are several conditions that were not accounted for during the installation of a roof over the building (see Picture 3). The peaked roof does not appear to have either ridge vents (see Pictures 4) or soffit vents (see Picture 5) to aid in air circulation within the roof space. Of note is the absence of a gutter/downspout system to direct rainwater from the base of the exterior walls. After rainstorms, the exterior walls are saturated with moisture (see Picture 6 and 6A). Rainwater runs off the roof onto the ground at the base of the building. This runoff has created a trench parallel to the base of the wall, which allows rainwater and melting snow to pool against the foundation and the exterior wall of this wing. Splashing water along the edge of the building wets the base of exterior walls (see Picture 7). Growth of moss on exterior brickwork is another indication of chronic moisture exposure from rainwater in this building system. Moss growth also holds moisture against brickwork. North facing corners and walls of this building are particularly vulnerable to moisture for extended periods of time, since this brick is not dried out by exposure to direct sunlight (see Picture 8). Excessive exposure to water of exterior brickwork can result in damage over time. During winter weather, the freezing and thawing of moisture in bricks can accelerate the deterioration of brickwork.

Roof of School

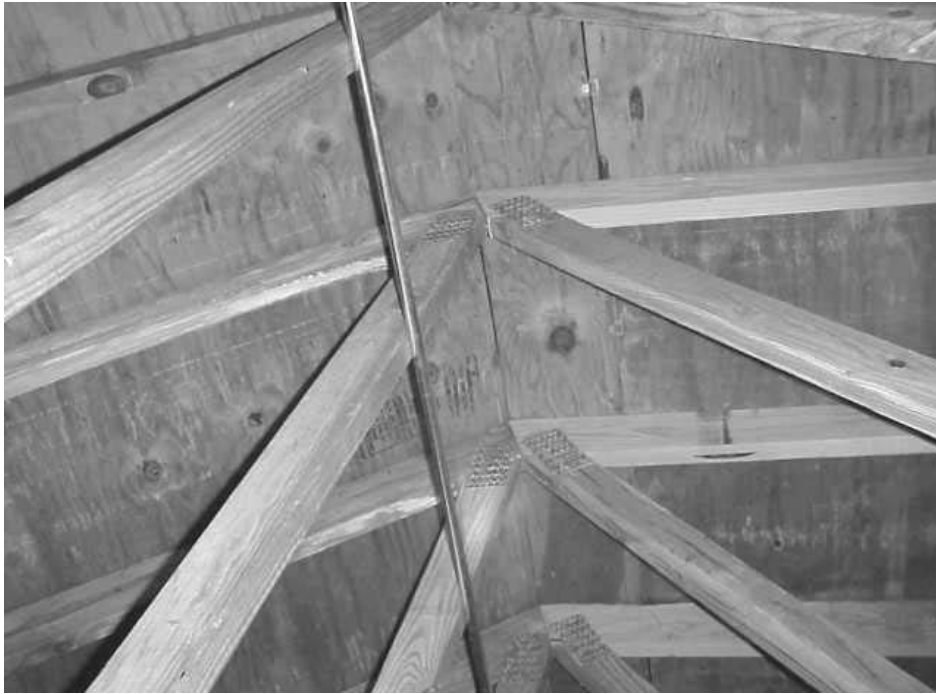
Picture 4

**View From Within Roof; Note no View of Exterior Light in Corners or in the Peak of Roof,
Which Indicates no Ridge Vent**

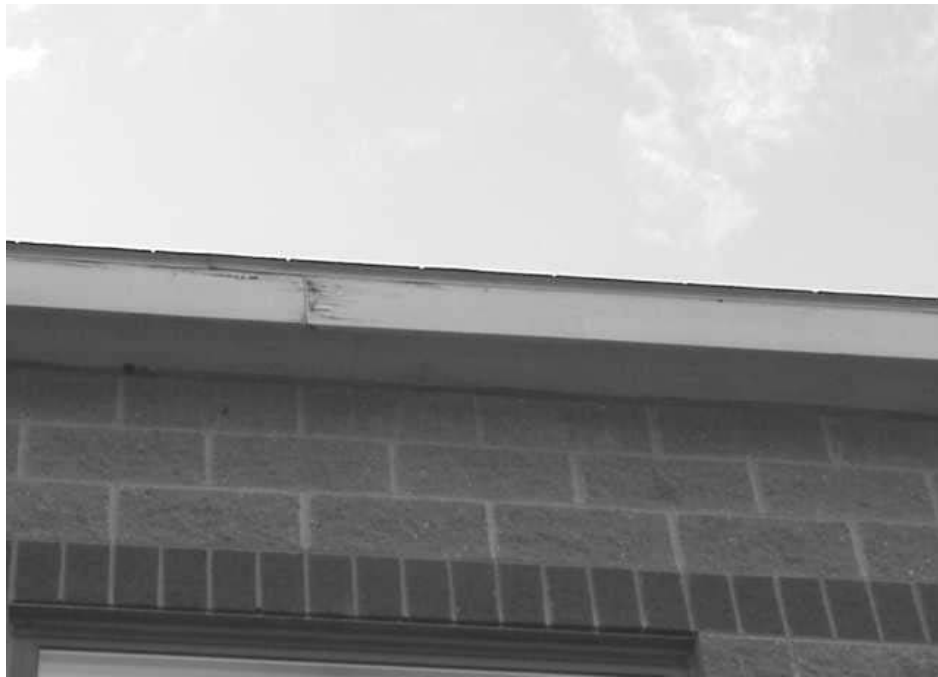
Picture 5

View From Ground of Soffit; Note no Soffit Vents and Deterioration of Wood at Joint

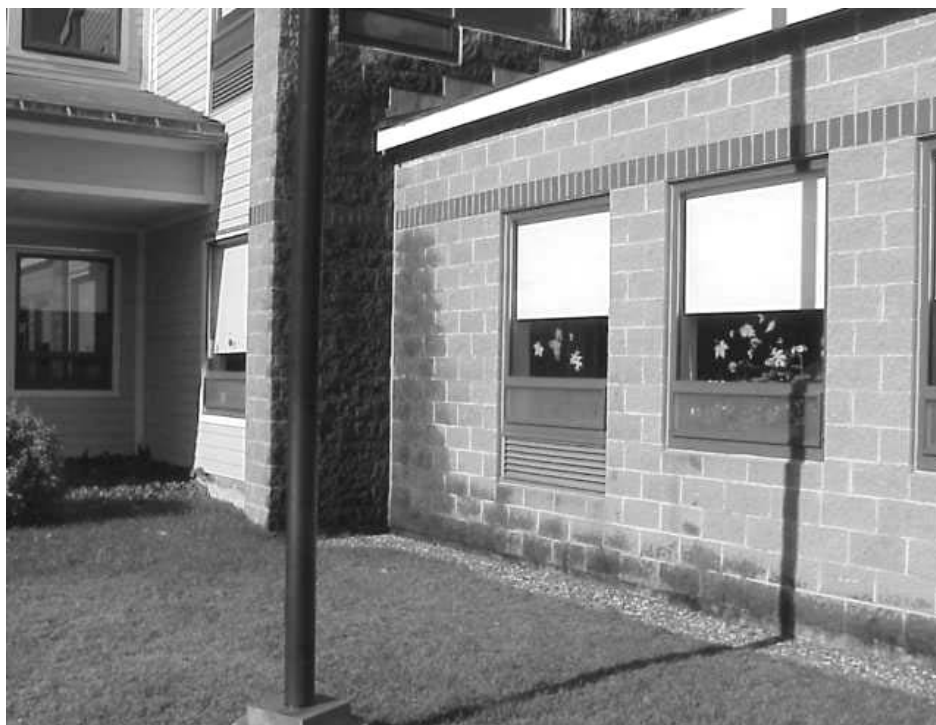
Picture 6

Moistened Brickwork, Photo Taken at 10:15 AM

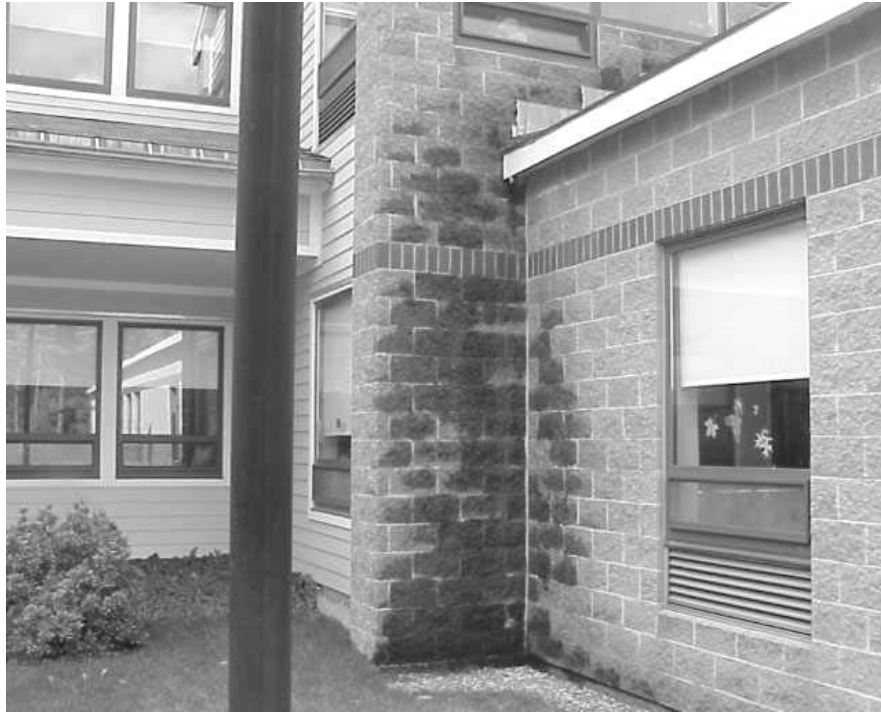
Picture 6A

**Moistened Brickwork Depicted in Picture 5, Photo Taken at 2:10 PM,
Note that Brick Has Not Dried Out After Four Hours**

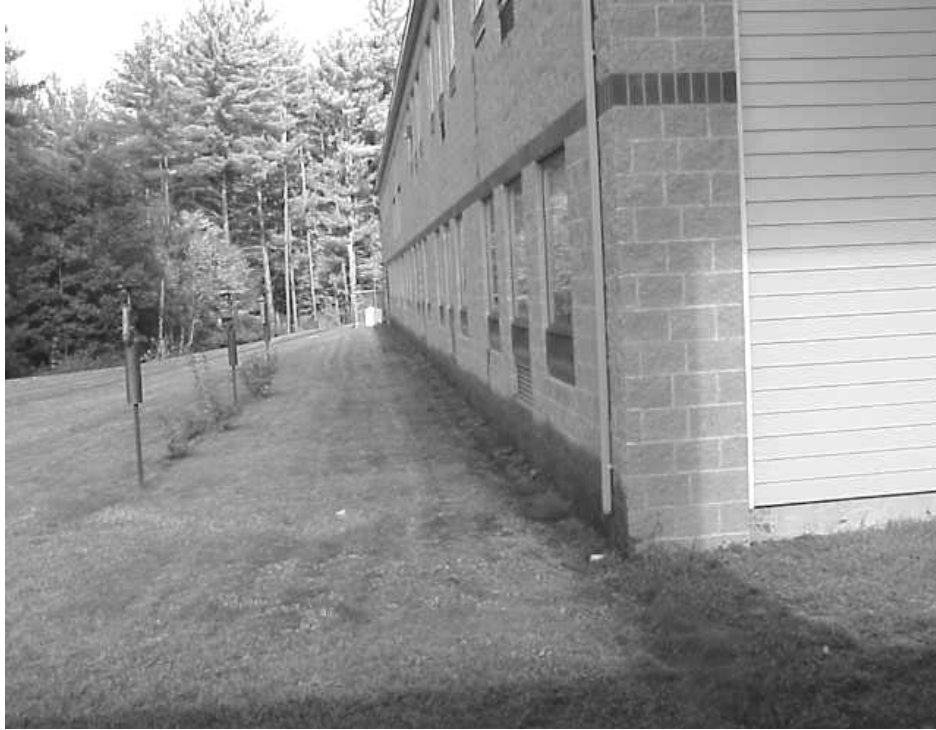
Picture 7

**Moistened Brickwork at Base of Rear Wall from Splashing Rainwater,
Note Furrow in Ground at Base of Wall Which is Created by Rainwater Running Off Roof**

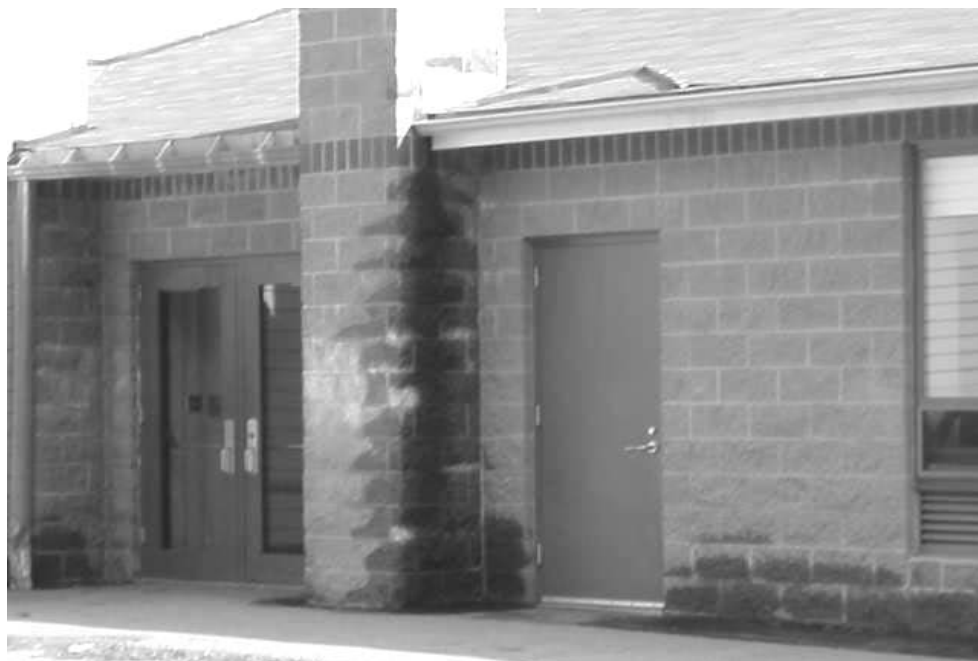
Picture 8

Moistened Brick Not in Direct Sunlight
